**Madison County Highway Department
2015**

Structurally Deficient Bridges

Madison County, New York

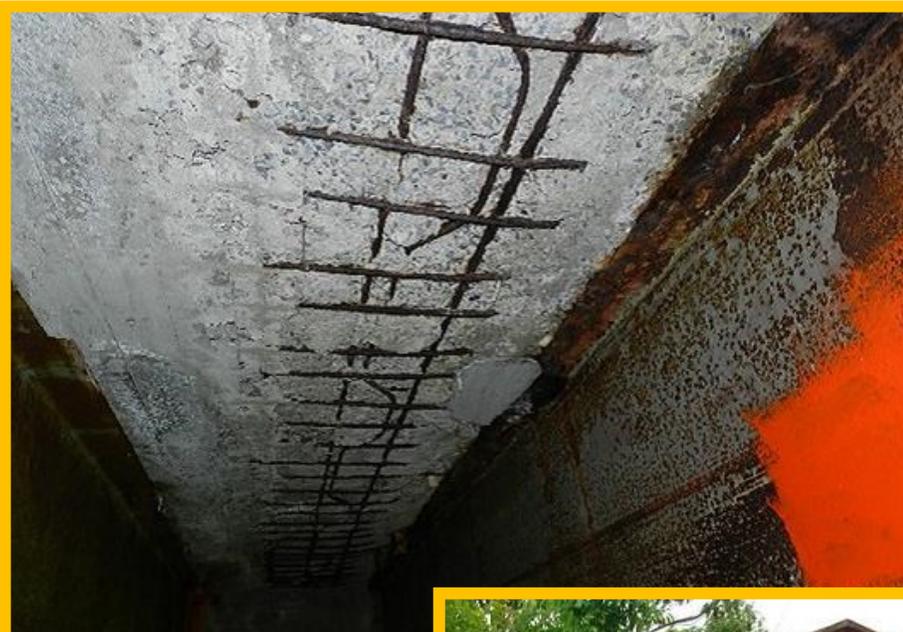
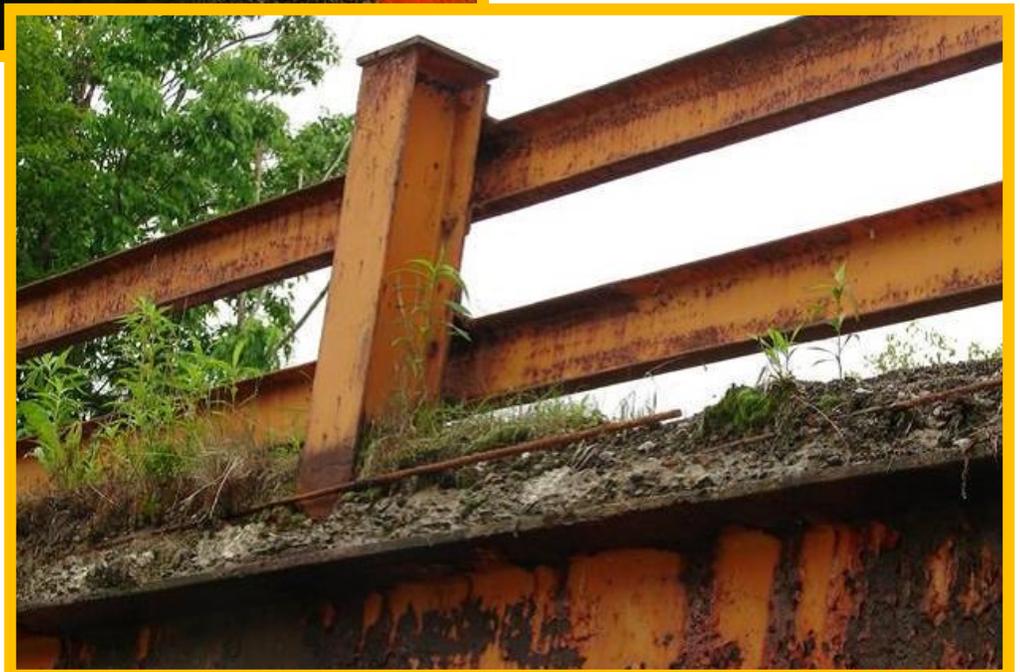
Ballina Road, Cazenovia

Efflorescence along the top flange of the left fascia girder, spall in other bays, severe efflorescence. In the end of bay 5, fascia of deck repaired in 2011, leakage through the left and right bay, moderate delamination at the end of G2, light scale on interior girders. Moderate delamination on the bearing plates.

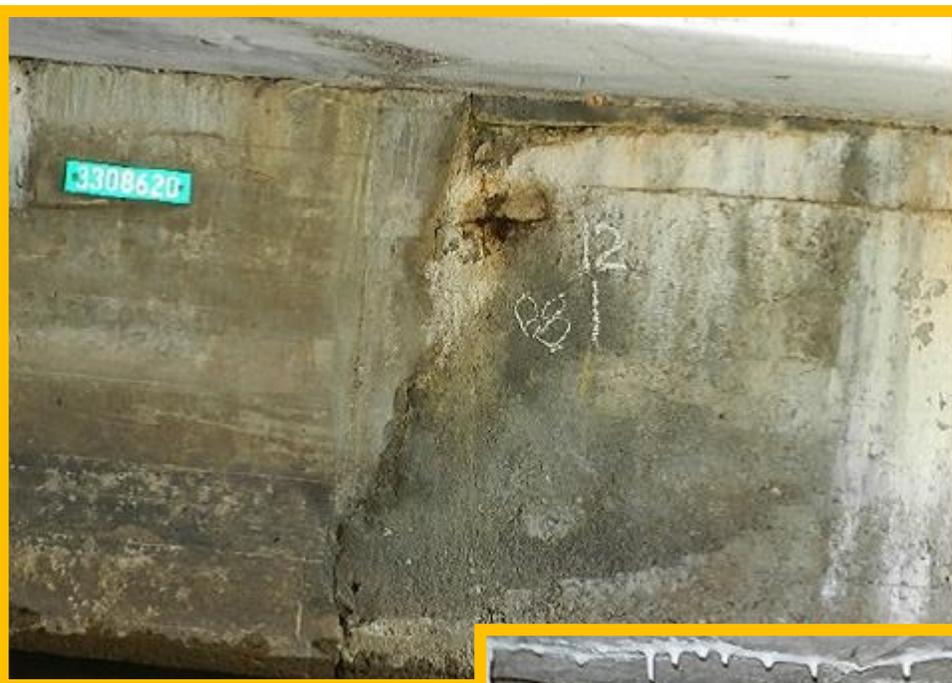
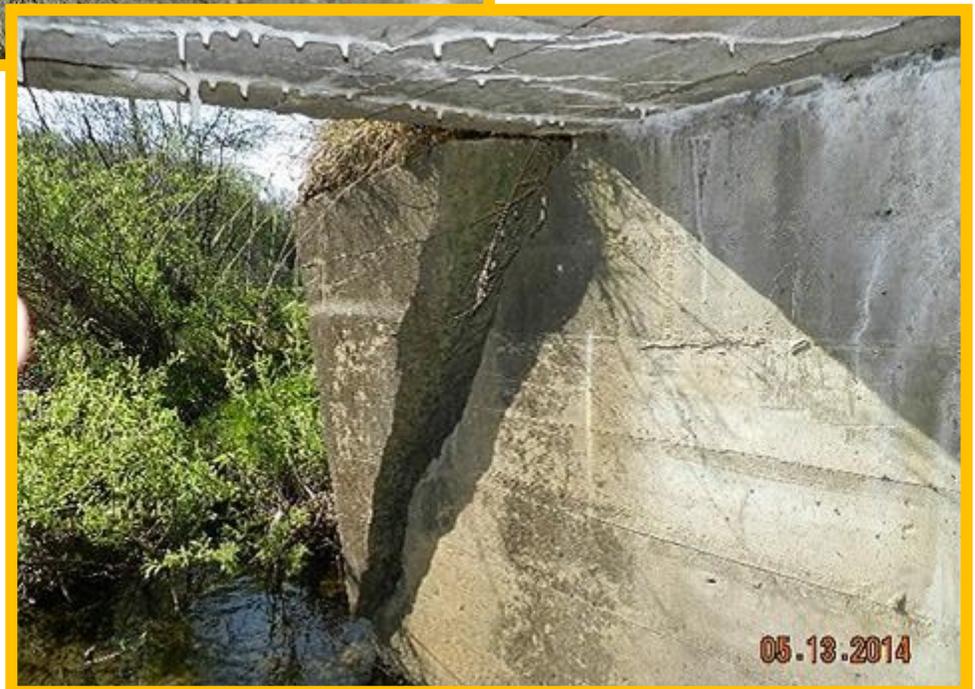
Beaver Creek Road, Brookfield

Primary Member rated 4, the end half of the concrete slab has several longitudinal cracks with dripping efflorescence and isolated hollow sounding areas, especially on the left half of the slab.

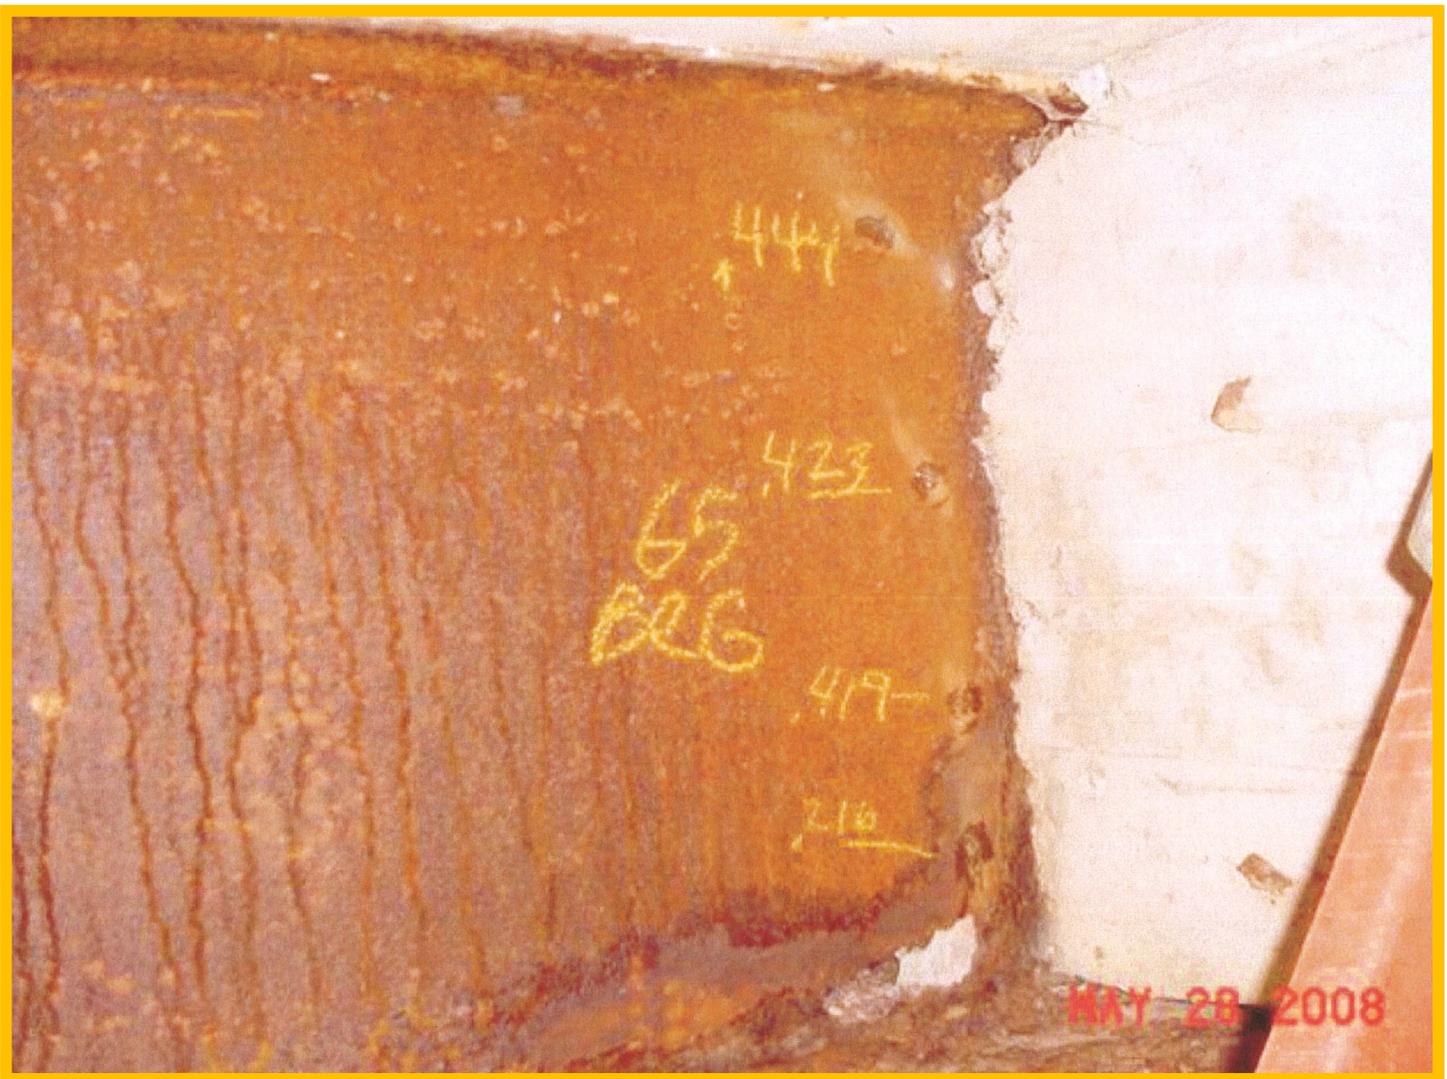
Campbell Road, Lebanon

Primary Members are rated 3, webs have heavy section loss up to 75% near bearing areas, bridge seat spalled, rated 4.

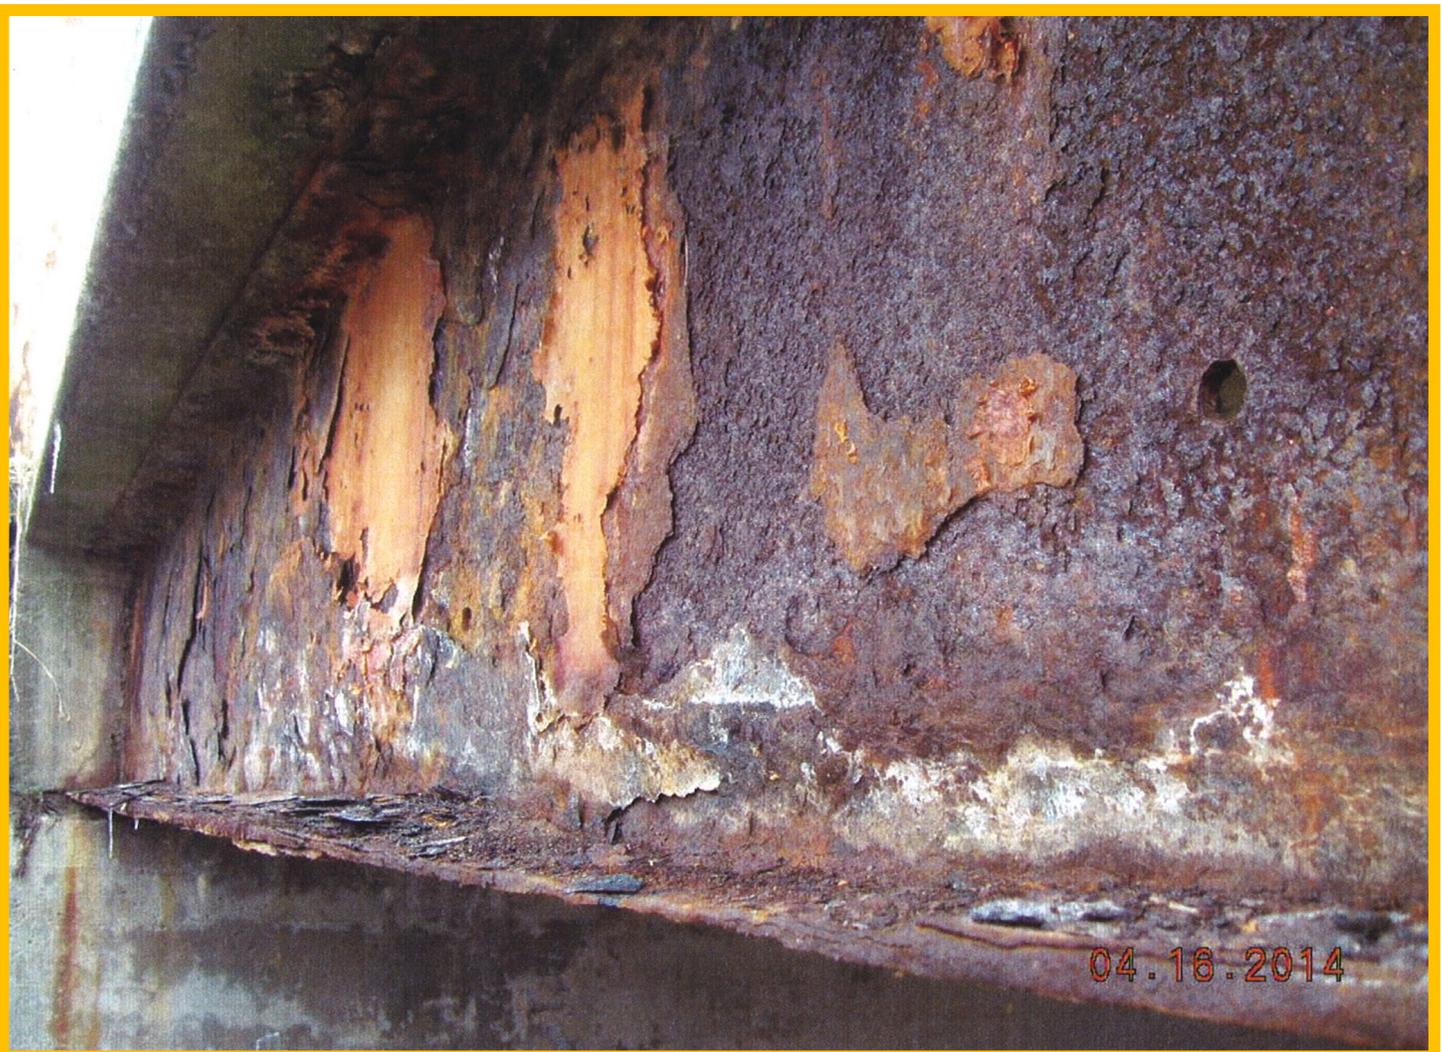
Clockville Road, Lincoln

Primary Member rated 3, girder 1 at mid-span has 56% section loss, girder 5 has flange section loss of 77%.

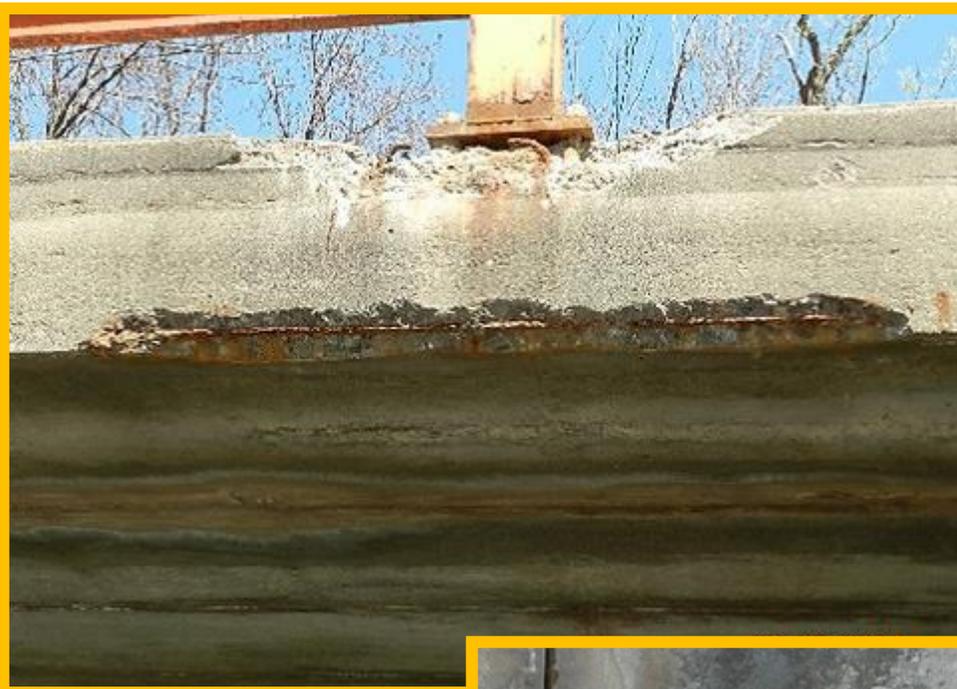
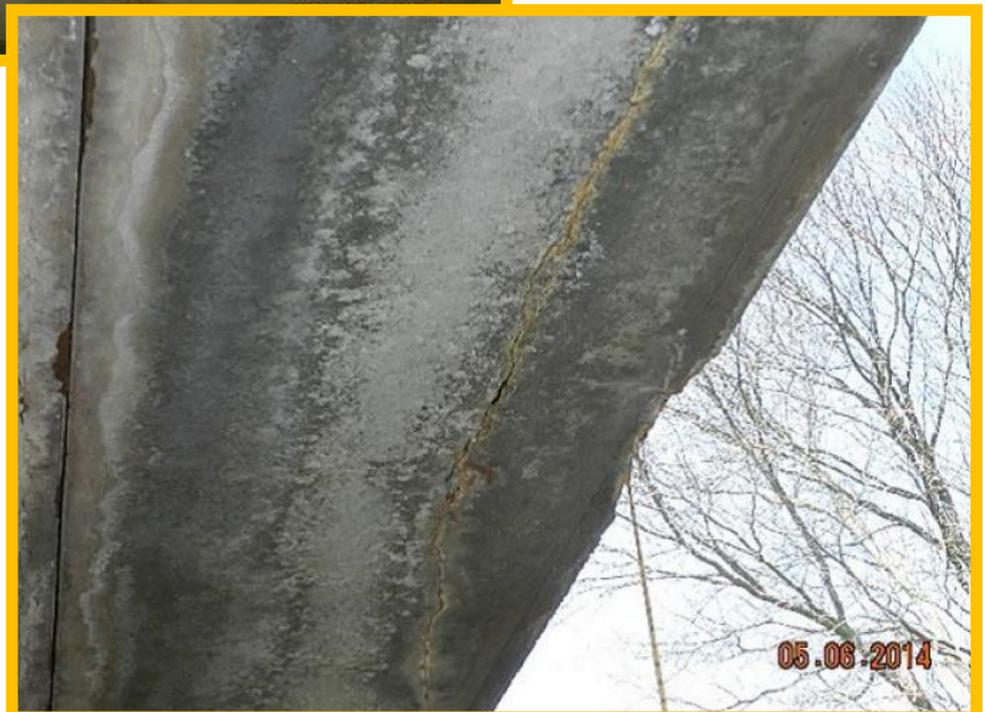
Creek Road, Lincoln

Primary Members rated 3, beam 8 has one exposed heavily corroded strand.

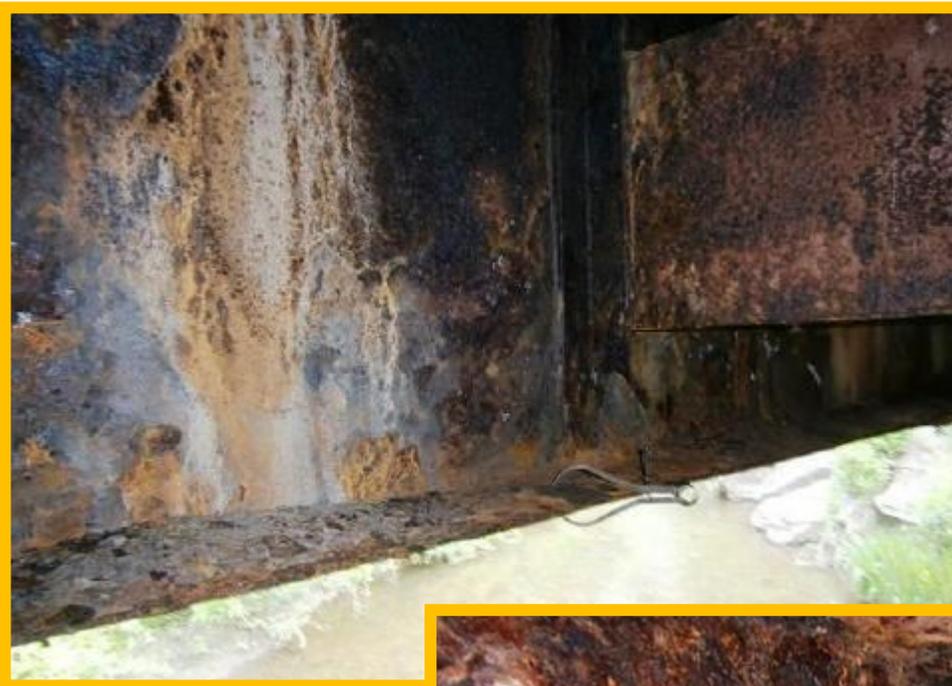
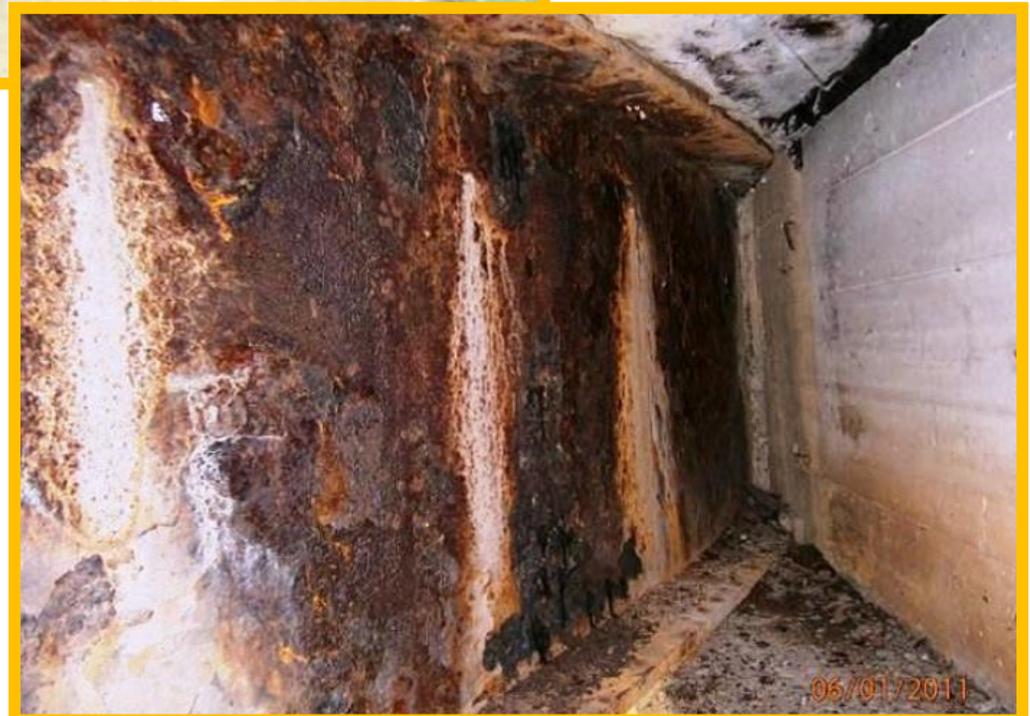
East Hill Road, Georgetown

Moderate scale, heavy scale and delamination on fascia girders at the bottom flange, up to 80% section loss, moderate delamination at the ends of a couple interior girders.

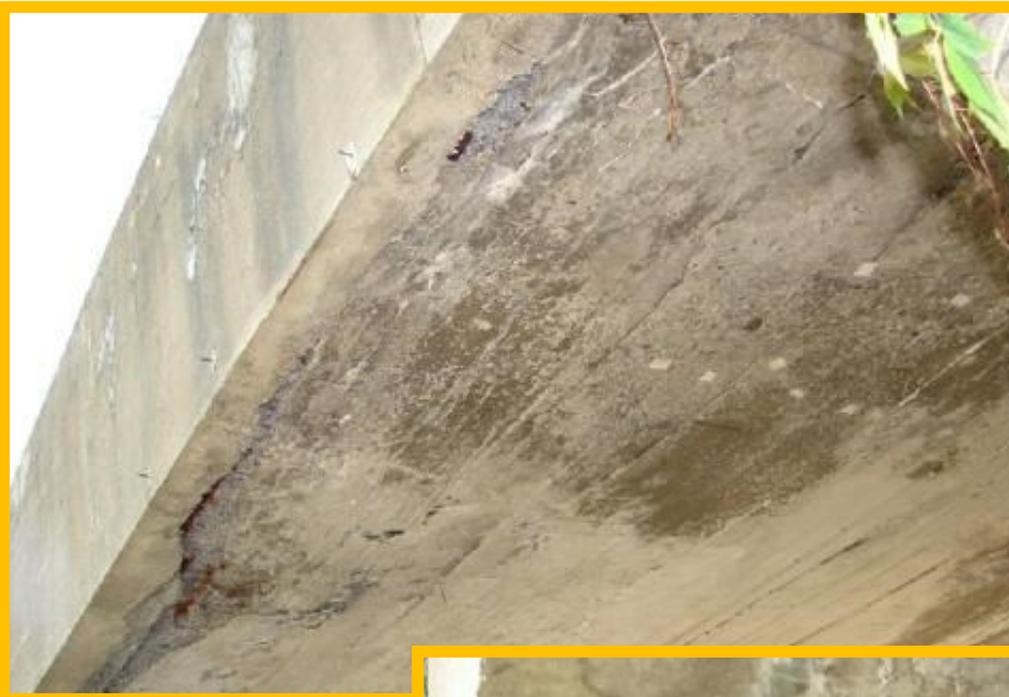
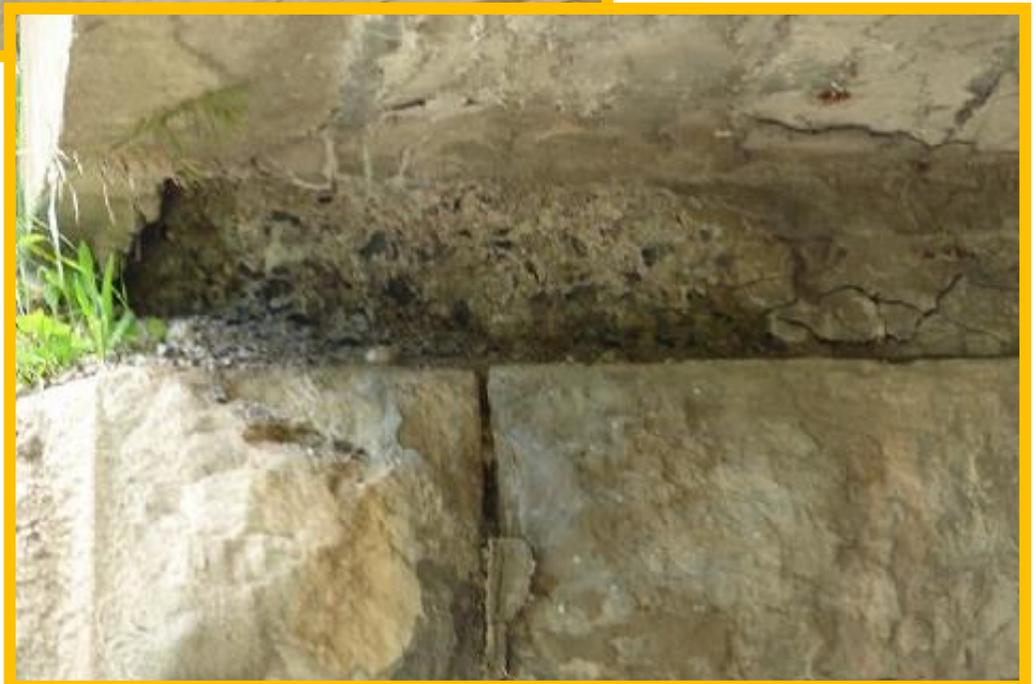
East Road, Cazenovia

Concrete Slab (primary member rated 3), spalled w/ rebar visible at edges, interior is in good condition, rated 5, abutment rated 4.

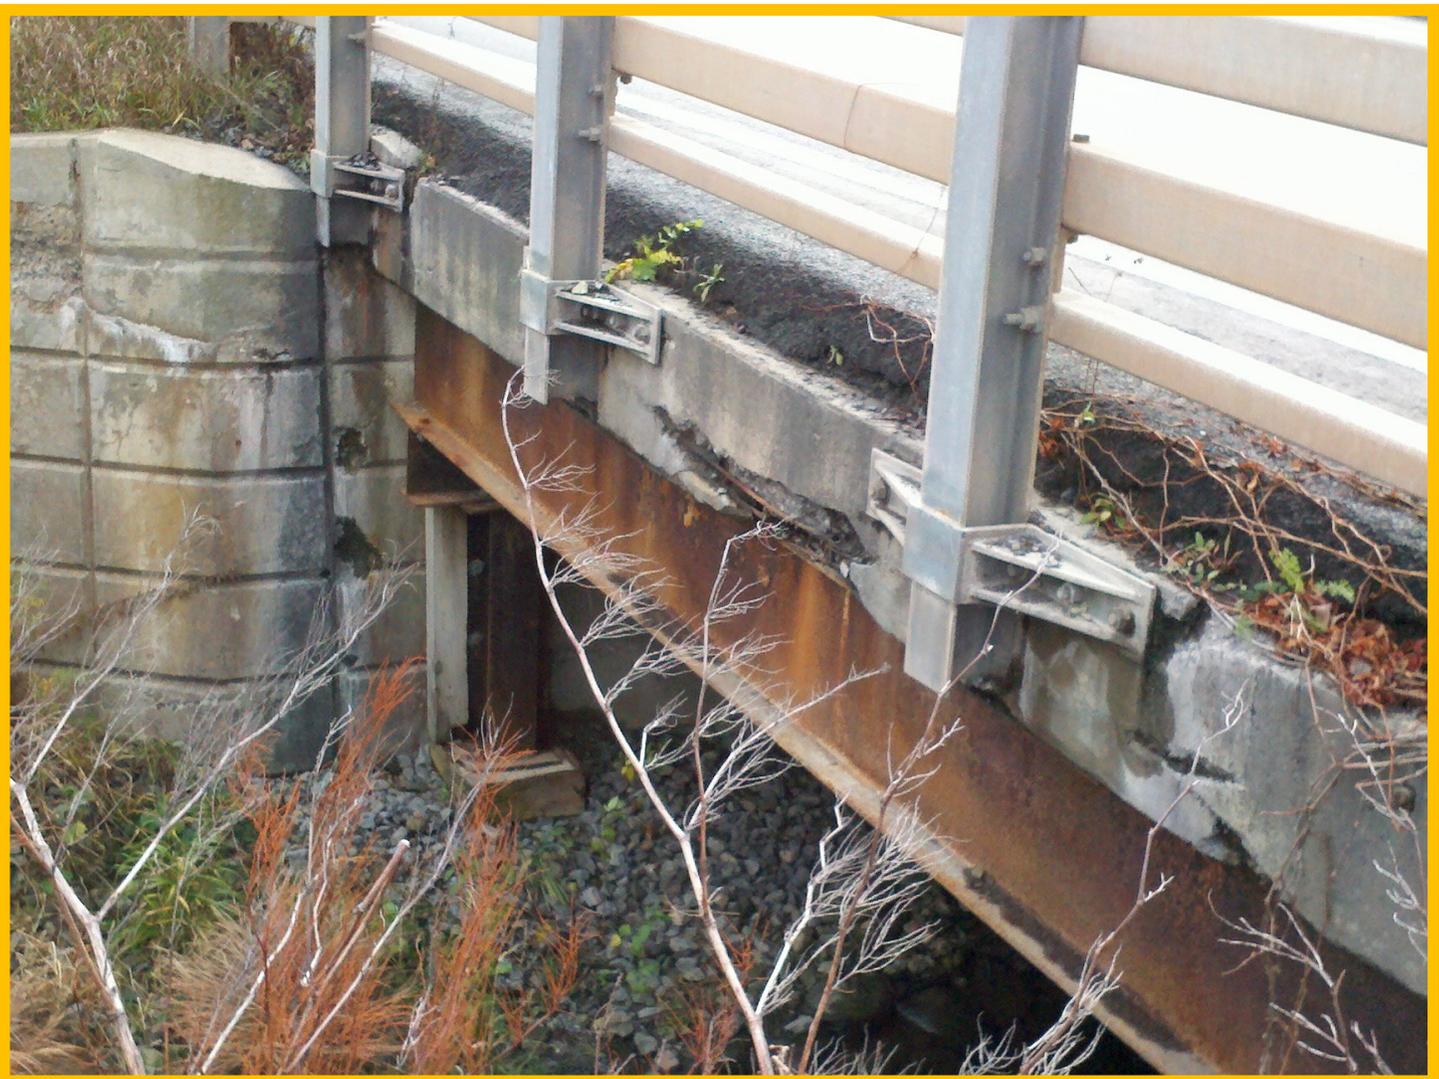
Eaton Road, Eaton

Primary Member rated 4, the right prestressed concrete beam is heavily spalled w/ 2 exposed tendons, one tendon is severed due to 100% section loss, left fascia beam is cracked w/ efflorescence.

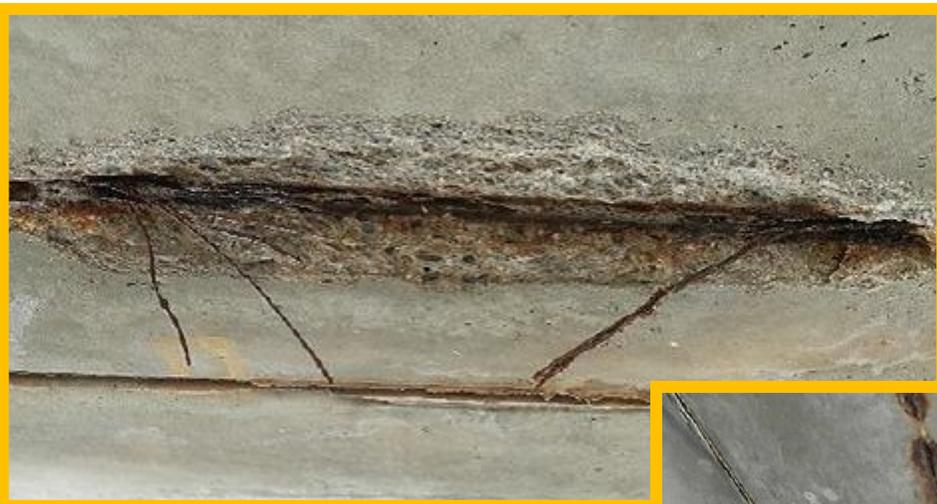
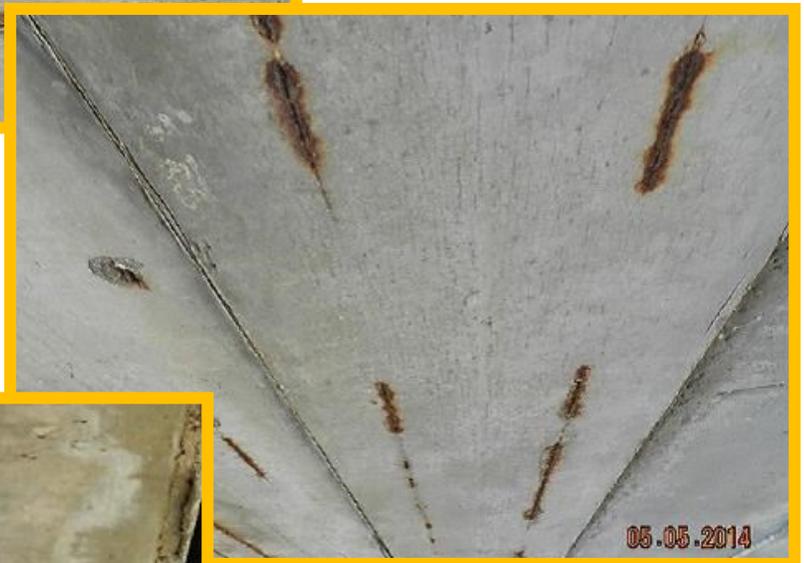
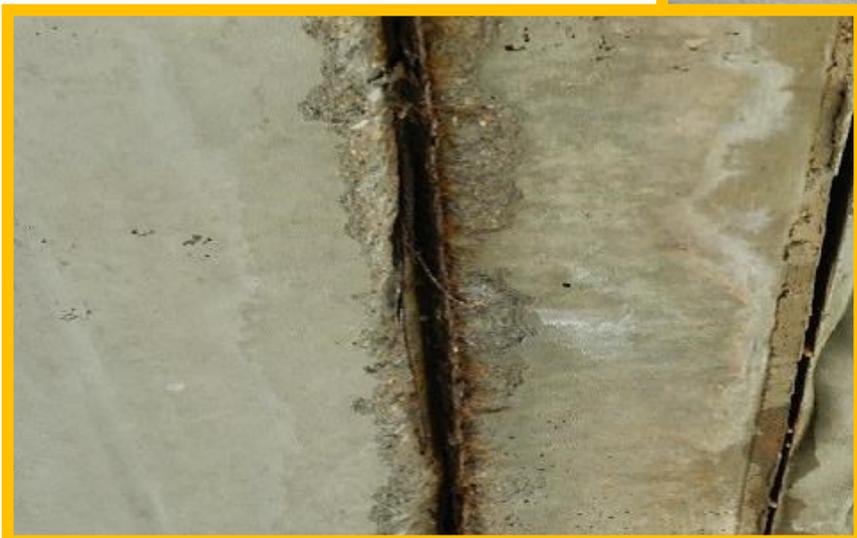
Glass Factory Road, Smithfield

Primary Member rated 4, two beams each have two longitudinal strands exposed, up to 100% section loss.

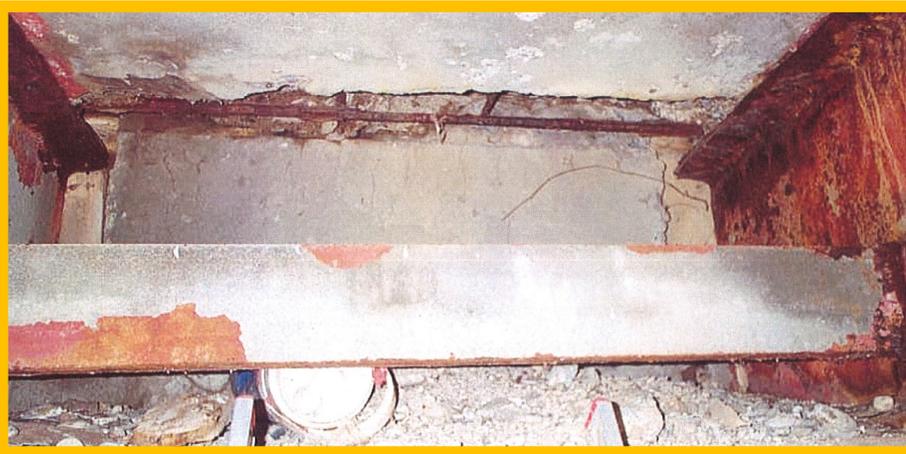
Picture above: Green Road bridge

Primary Members rated 5, minor (<5%) section loss to the upper flanges of girders; Structural Deck rated 3, deck has transverse cracks w/ efflorescence and minor spalling.

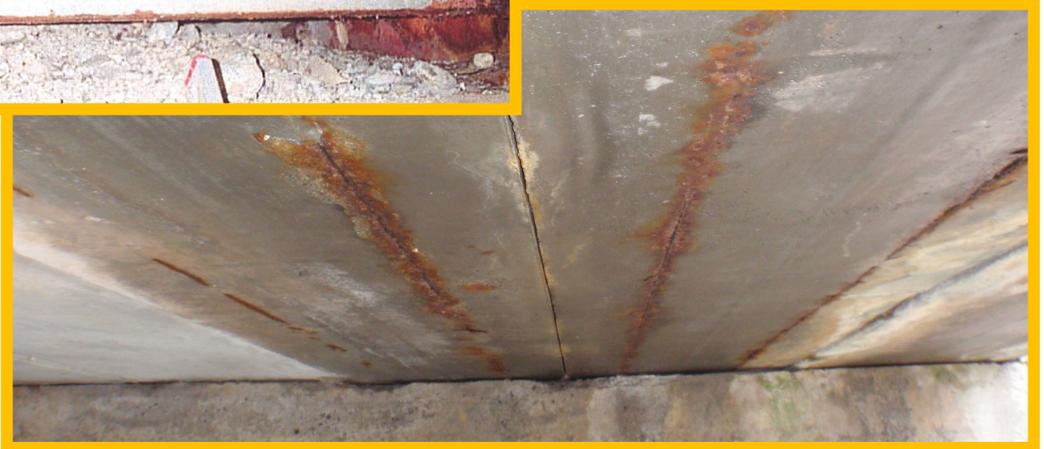
Picture below: Harsh Road bridge

Primary Members rated 3, three beams have longitudinal tendons exposed w/ 20% to 50% section loss, one beam has 1 of 2 exposed tendons w/ 100% section loss.

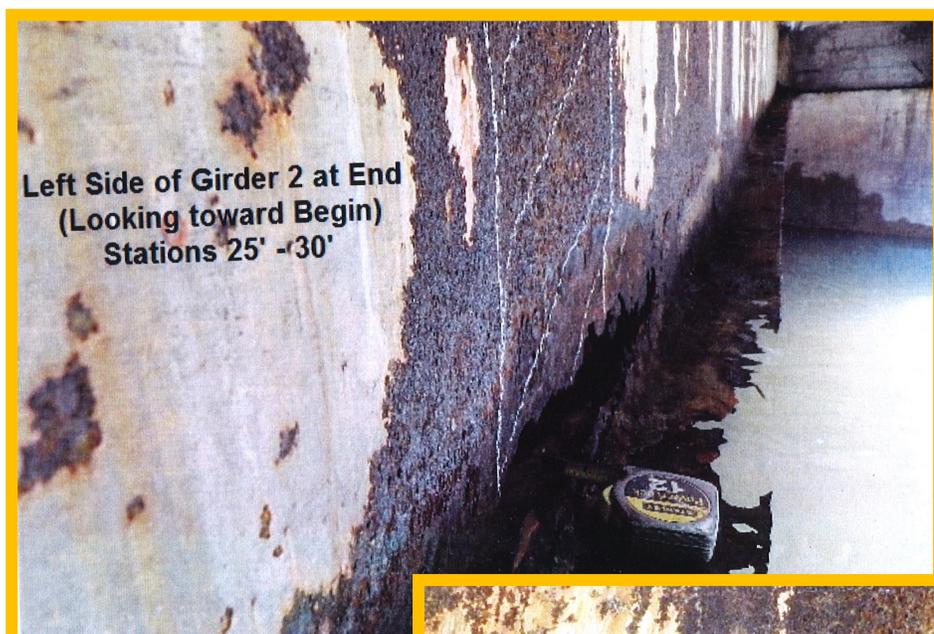
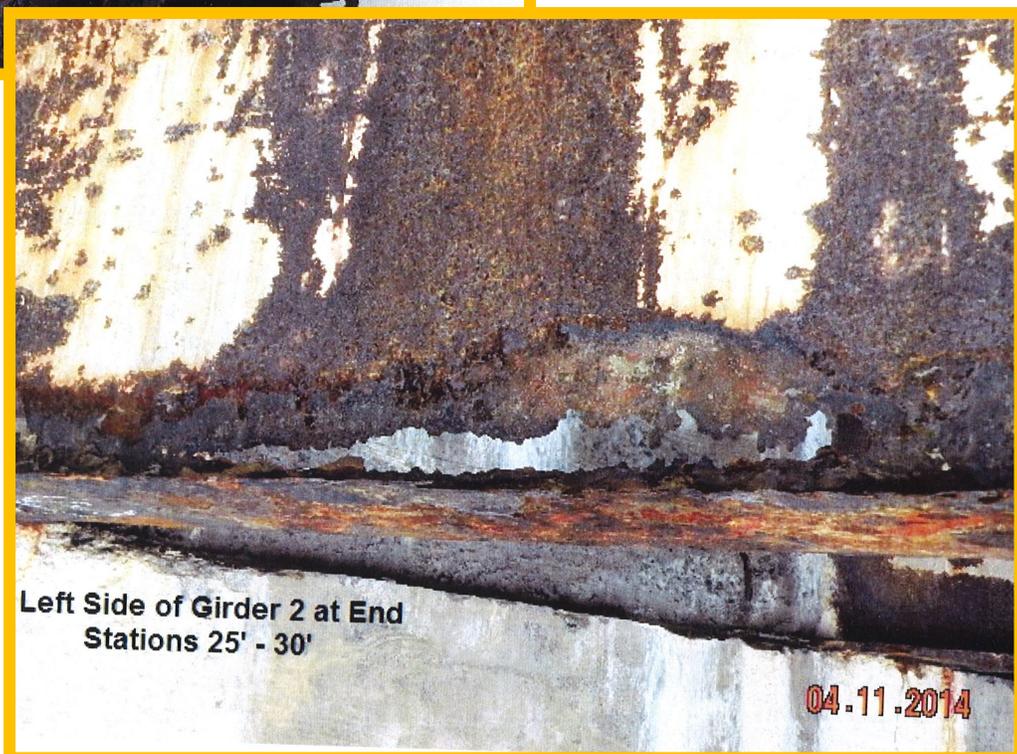
Hunt Road, DeRuyter

Primary Members rated 3, w/ girders having section loss, G2 has up to 100% section loss on the web near bearing area, structural deck rated 3, cracking w/ dripping efflorescence, bridge seat has moderate spall, starting to undermine steel bearing plate, rated 4.

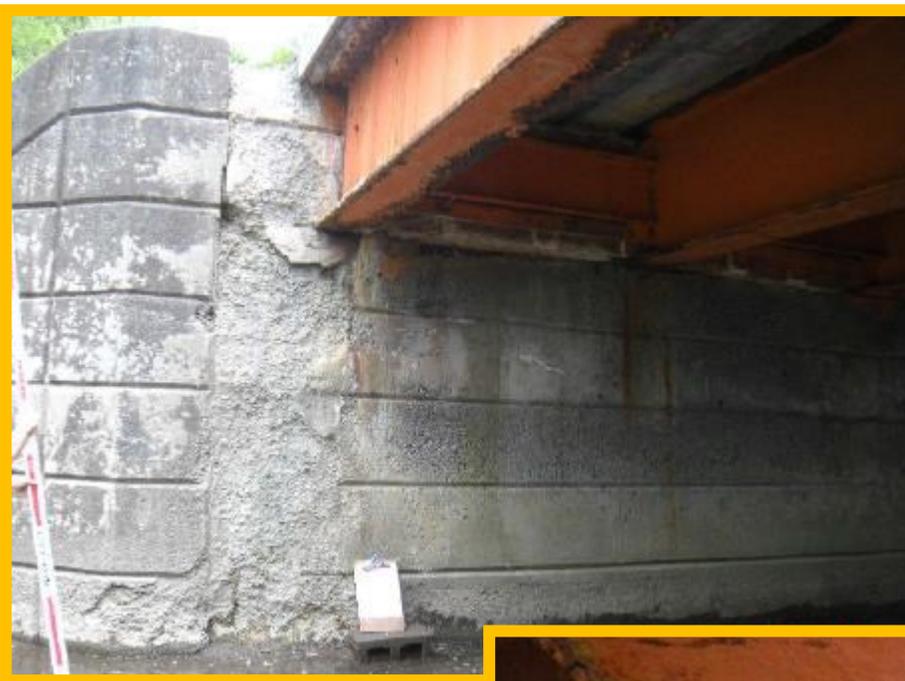
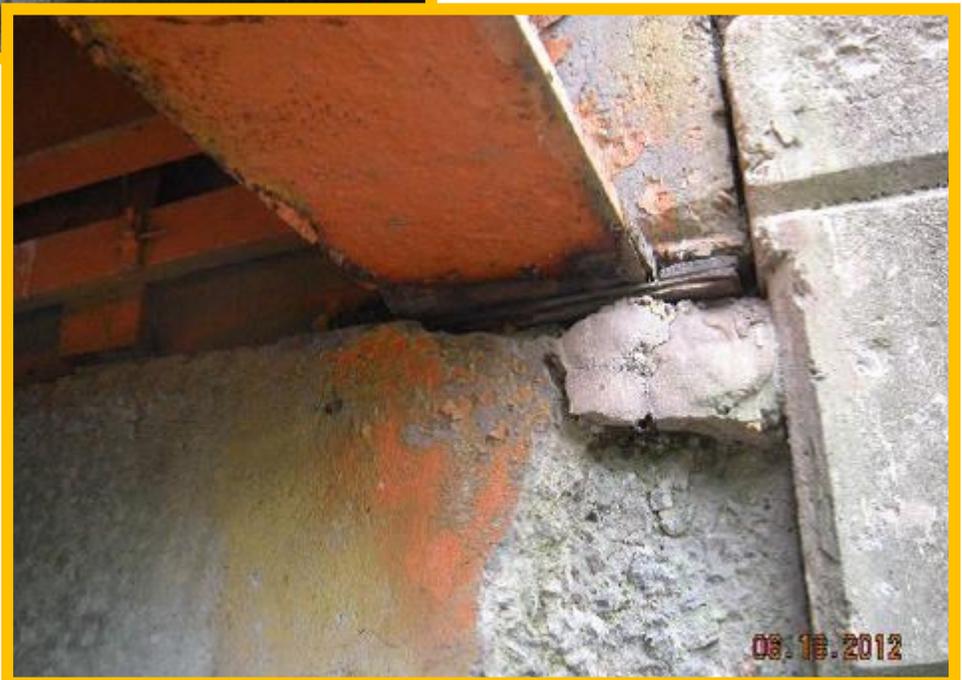
Landon Road, Eaton

Primary Member rated 4, w/ both fascia girders having 10% to 20% web section loss, flange loss of the fascia girder is up to 5%; End Bridge seat at G-5 is spalled to 5 1/2" deep, 10% loss of bearing; structural deck is rated 3.

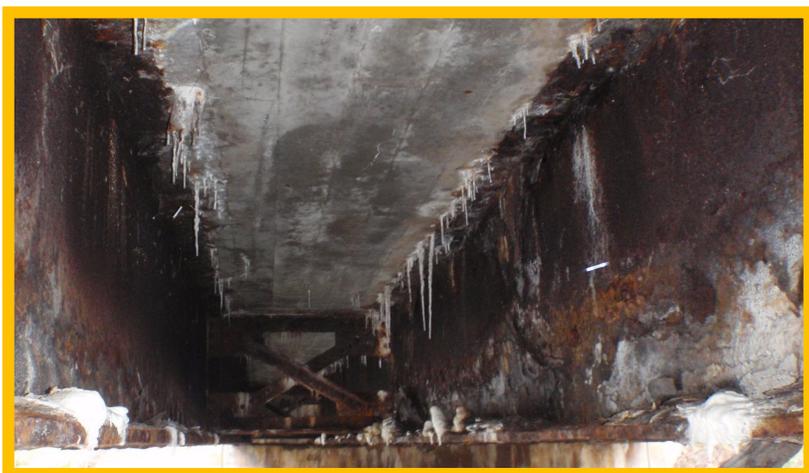
Picture above: McGraw Road bridge

Primary Members rated 4, interior girders have heavy web section loss, up to 35%, up to 29% bottom flange section loss; Structural Deck is rated 3.

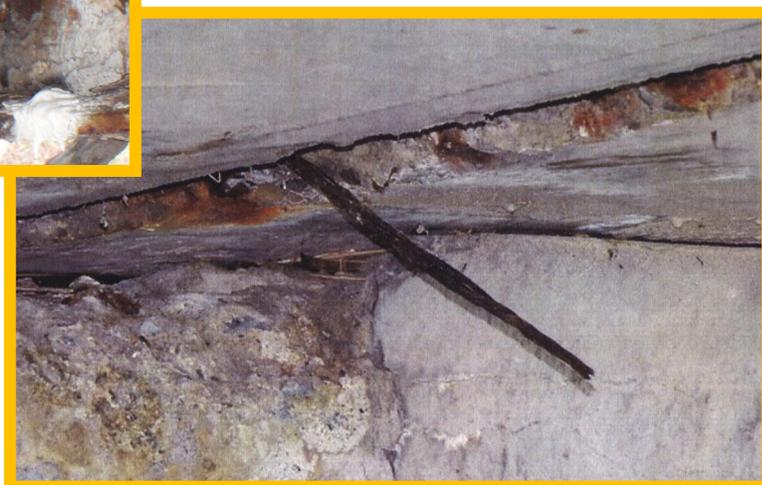
Picture below: Middle Lake Road bridge

Primary Members rated 4, localized spall w/ reinforcement exposed, exposed tendon has 100% section loss, abutment rated 4 due to spall at bridge seat, end abutment footing rated 3, due to possible movement.

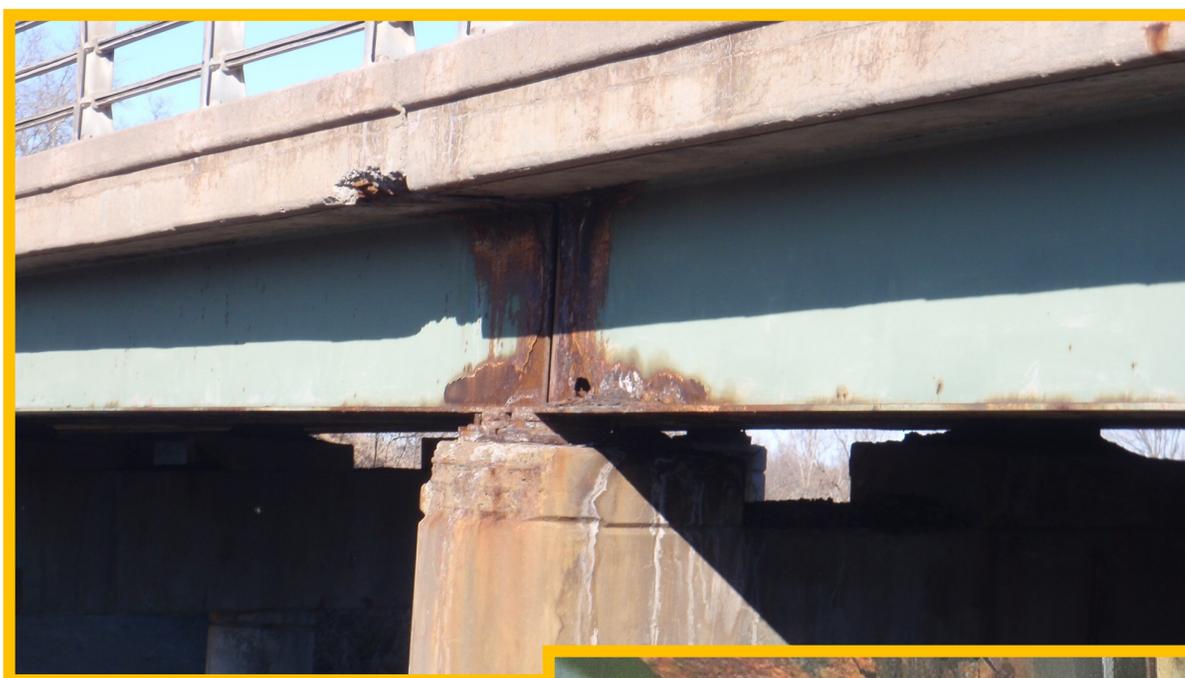
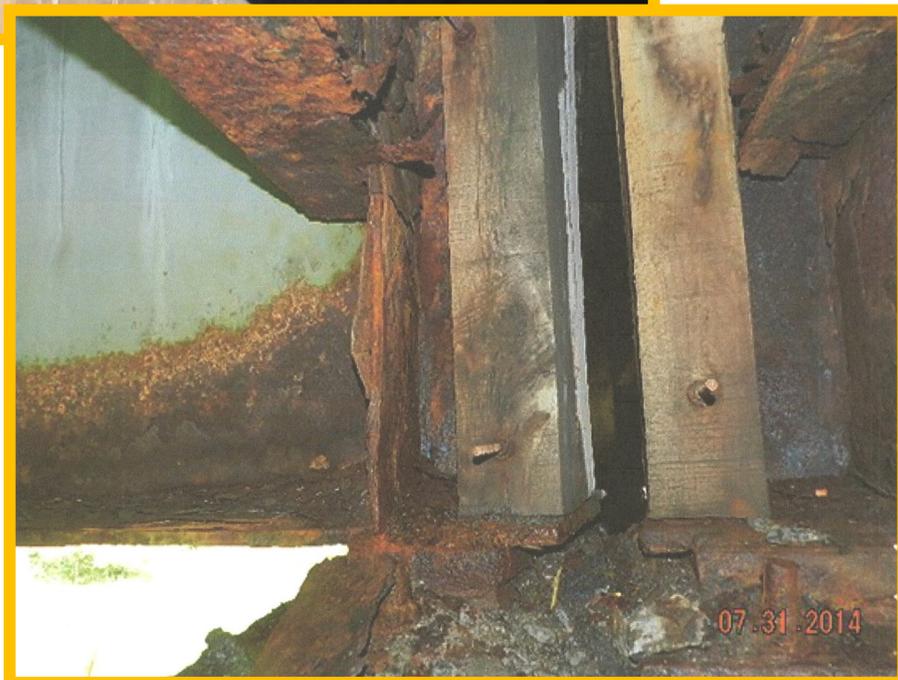
North Court Street, Lenox

Heavy web section loss of girders in span 2 over the pier 2 bearings, section loss up to 82%, up to 50% section loss in webs of girders in span 1 over the pier 1 bearings, girders in span 3 have up to 56% web section loss over the pier 2 bearings.

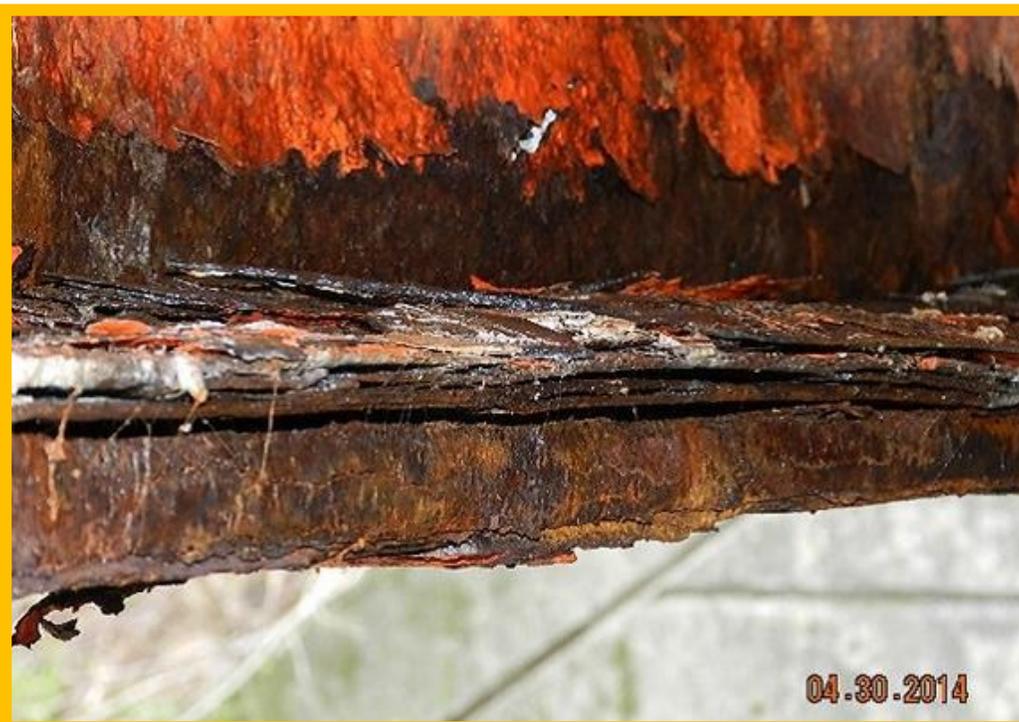
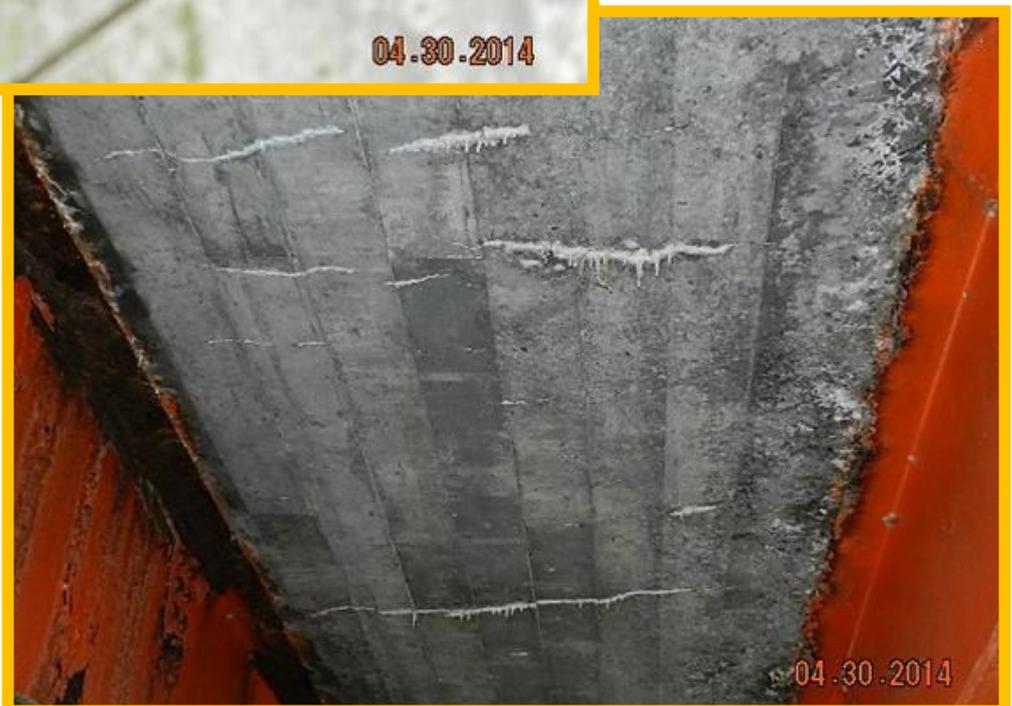
Nower Road, Lebanon

Primary Members rated 4, girders have up to 30% section loss on web and 19% section loss on flanges.

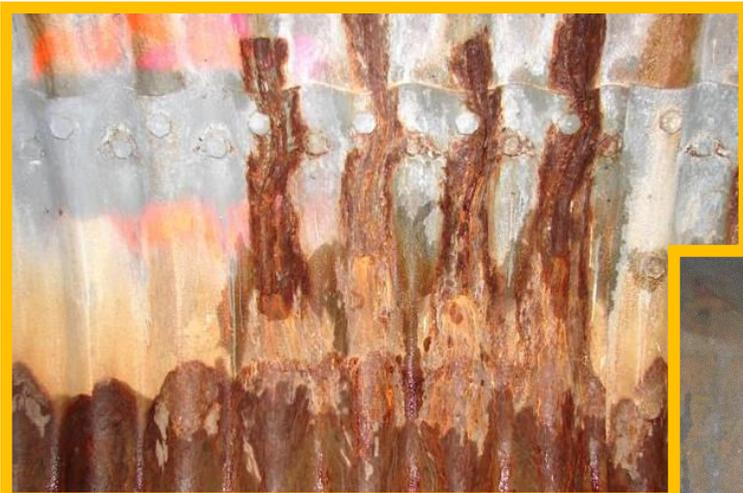
Picture above: Oxbow Road bridge

Stress cracks surrounding structurally bolted connections and section loss of steel plates.
