**Madison County Highway Department
2015**

Structurally Deficient Bridges

Madison County, New York

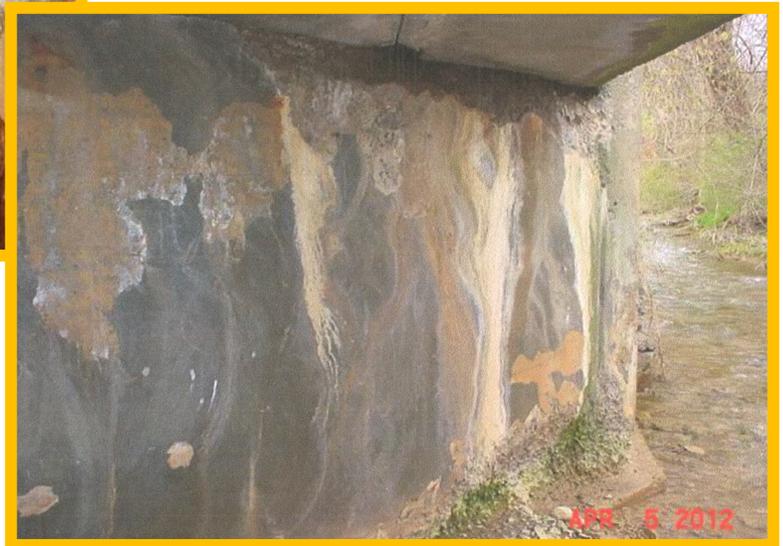
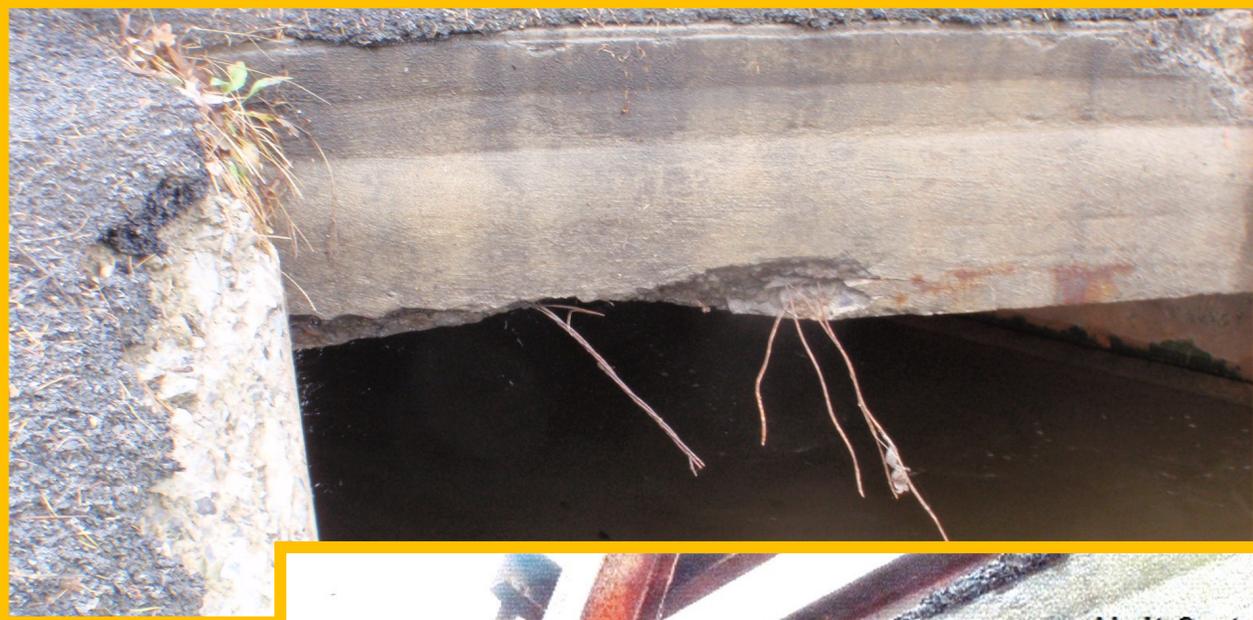
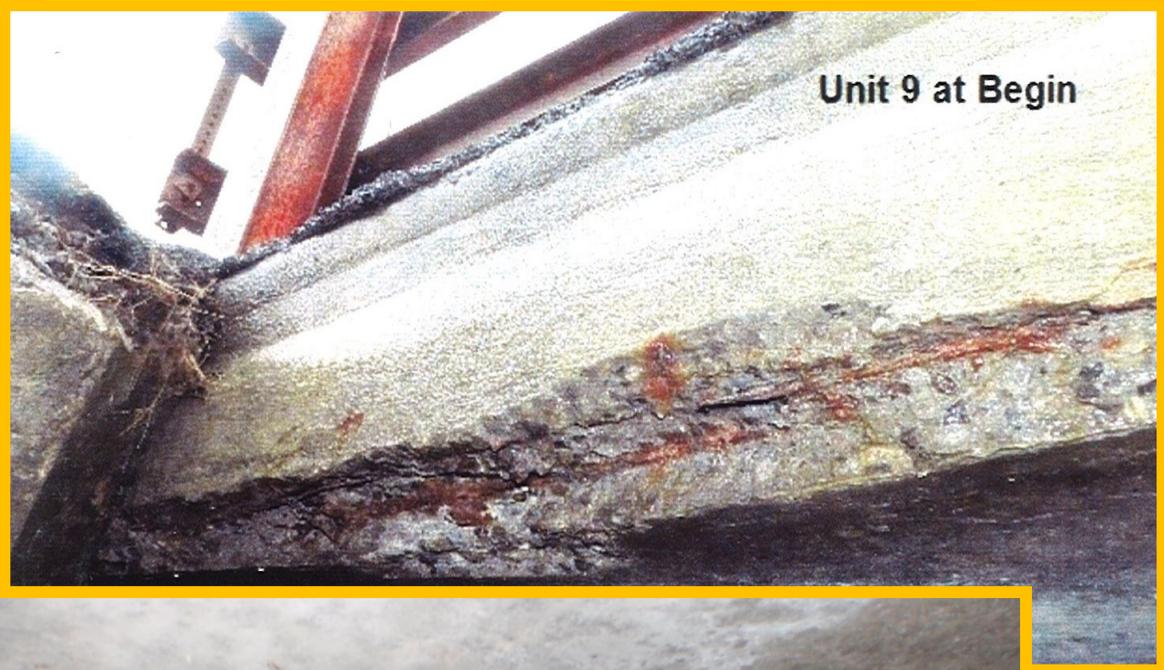
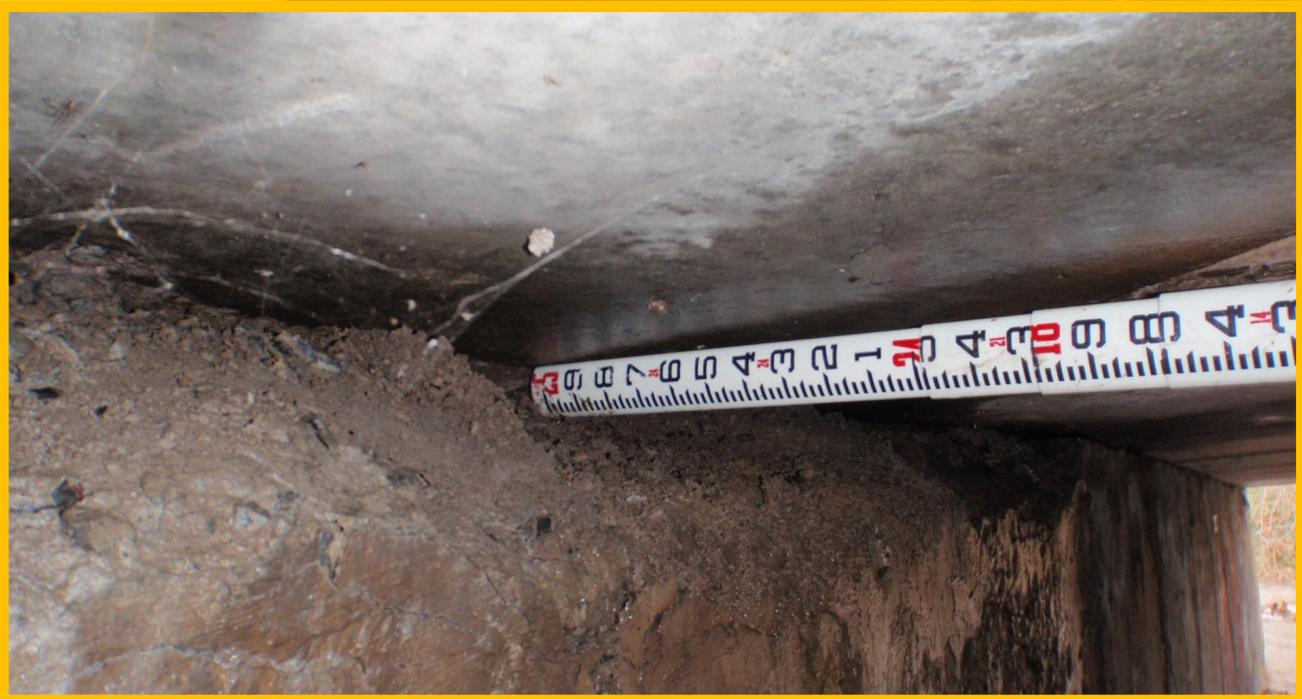
Pictures: South Court Street bridge

Primary Members rated 3, two beams spalled w/ prestressed strands exposed w/ 100% section loss; longitudinal cracks in other beams, hollow sounding near cracks, the begin

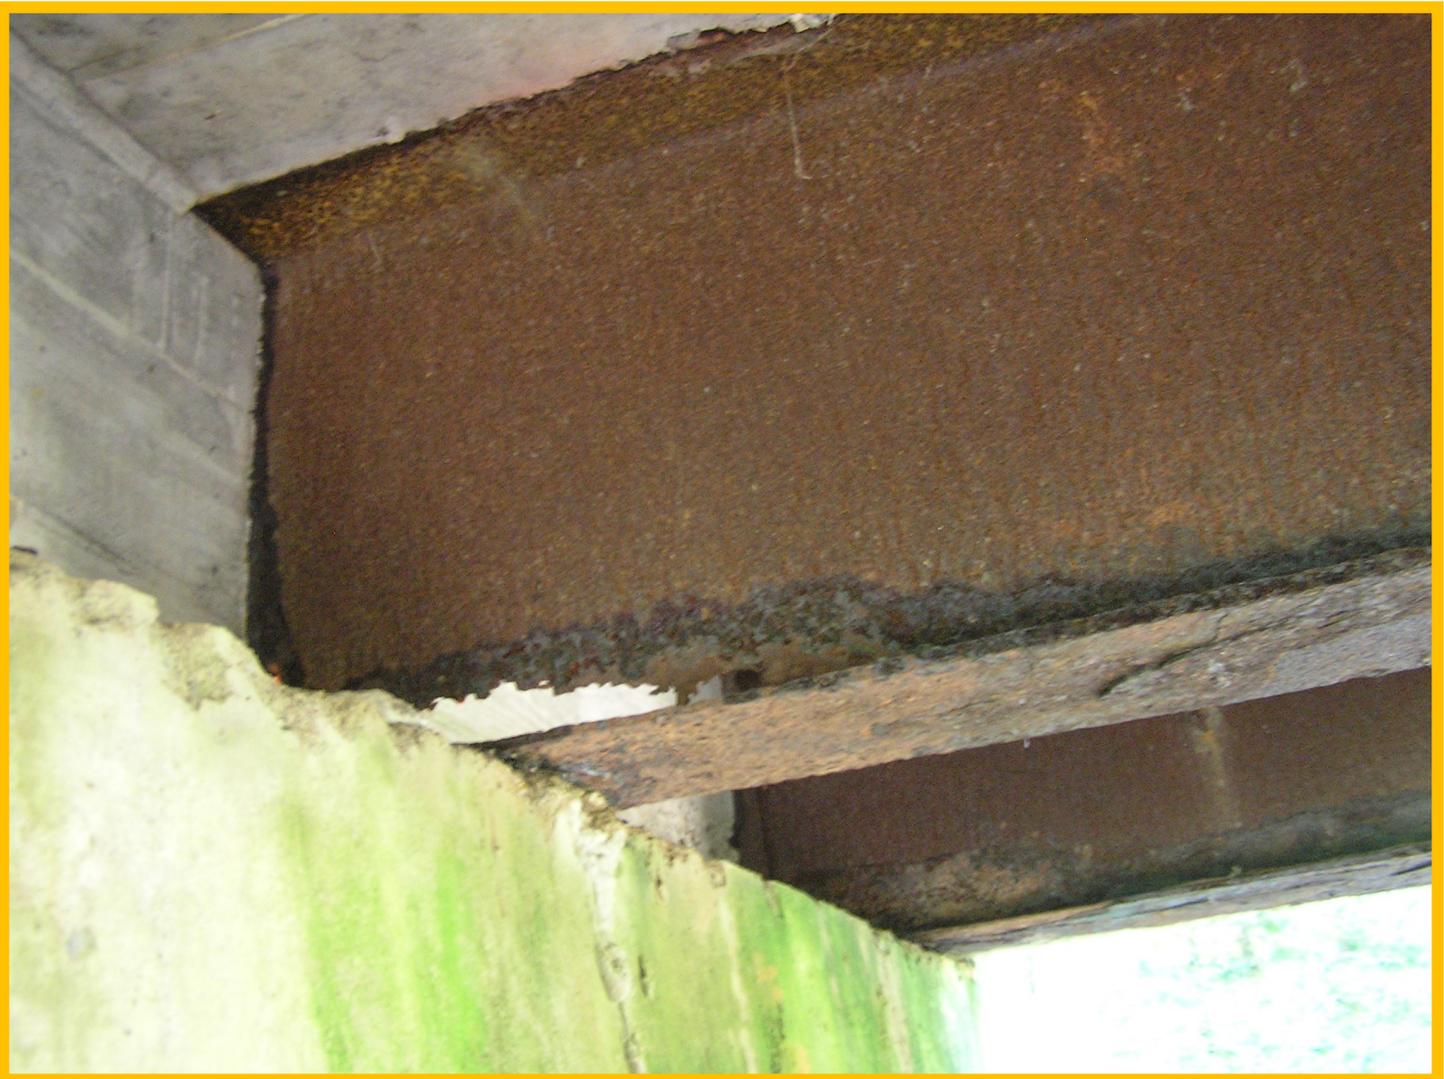
South Hamilton Road, Hamilton

Primary Members rated 4, Girder S2 has heavy section loss over the begin bearing area with rust perforations, the lower portion of the web of adjacent girder S1 has approx. 30% section loss at the begin. The lower portion of the web of girder G5 and G2 has a band of 100% section loss over the bearing, G1 end also has a band of severe section loss over the bearing, up to 60% structural deck rated 4.

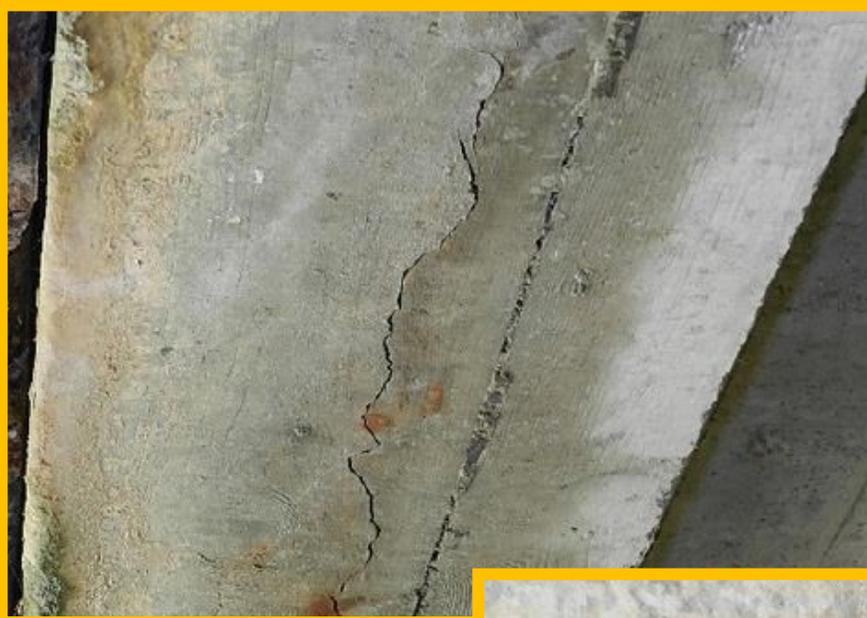
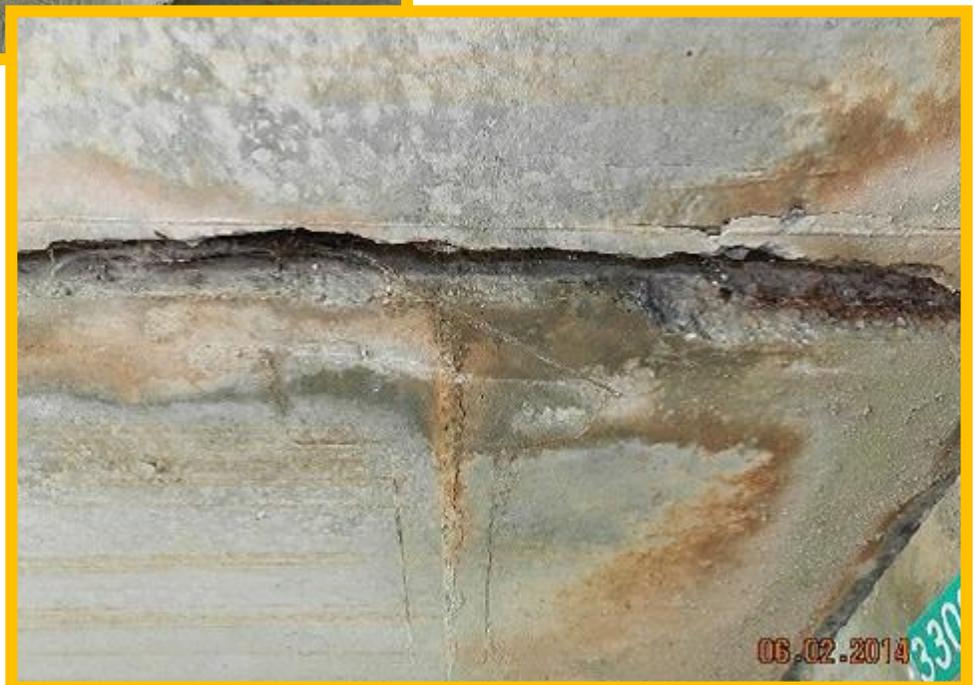
Valley Mills Road, Stockbridge

Primary Members rated 4; Beam #2 is spalled 3' long by 4" deep near the begin stem exposing one severed strand and one moderately rusted strand. Beam #3 is spalled 4' long by 4" deep at 1/3 span exposing one severely rusted strand with several broken wires.
